## Prudhoe Bay, Alaska - Oil Drilling Platform

**Location:** Prudhoe Bay, Alaska

**Product:** Nilex MD-7407 Wick Drains

**Contractor:** Nilex Construction LLC

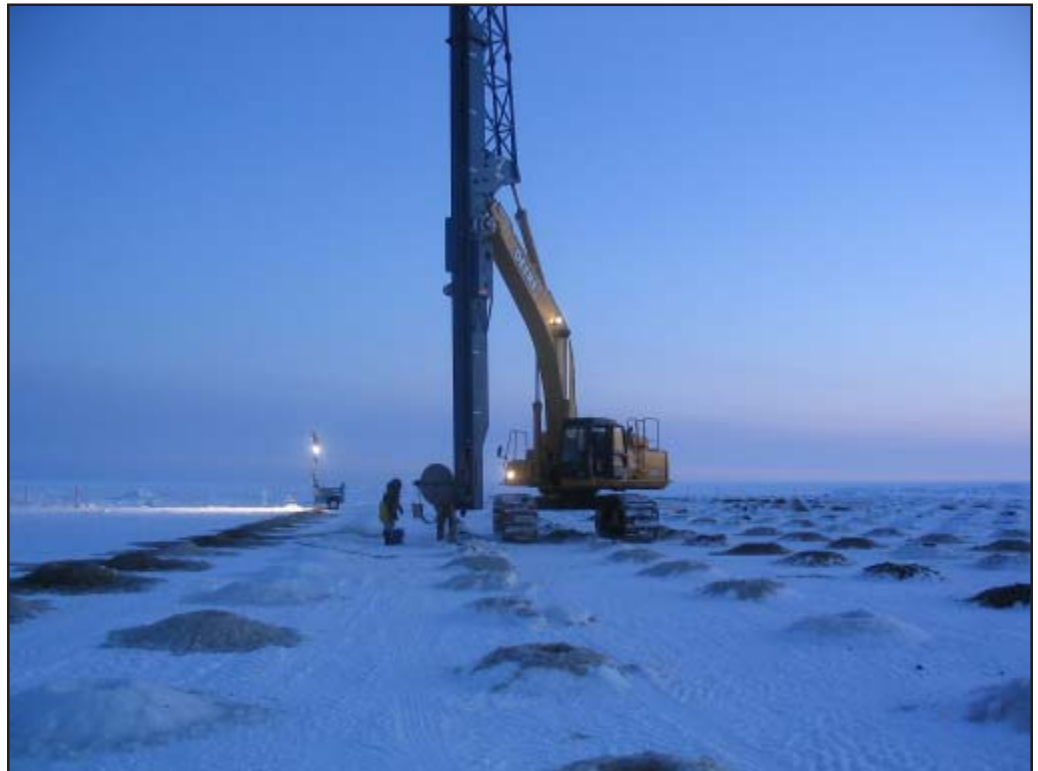
Figure 1

*Due to a tight time-line and sub-zero temperatures, crews installed wick drains around the clock.*

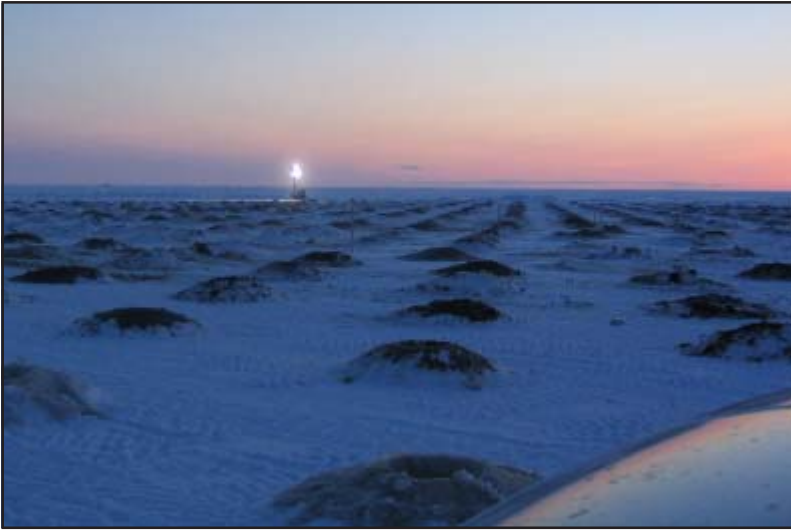
Figure 2:  
*Preaugered holes drilled through ice prior to wick drain installation.*

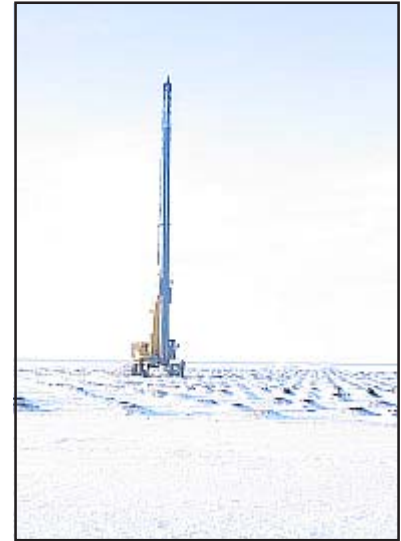
Figure 3:  
*Installing wick drains on the wick drain pad.*
